Vale completes important stage in tailings containment and water treatment

Sheet pilings curtain and water treatment plant are part of a set of projects which contribute to reduce tailings flow into the Paraopeba River

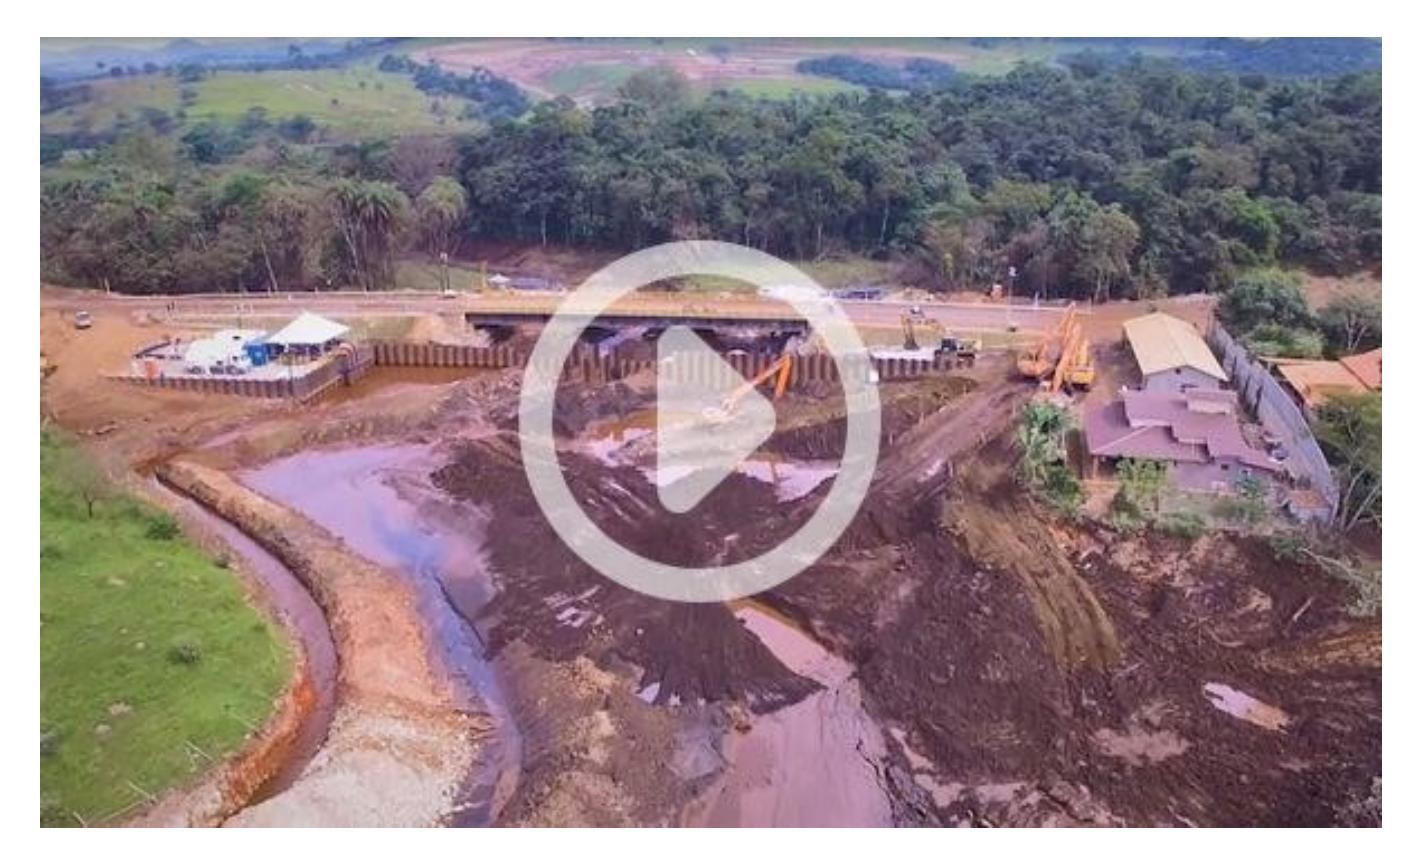
Vale completed a sheet pilings curtain, located upstream of the Alberto Flores bridge, in the rural area of Brumadinho, Minas Gerais. This operation contributes to reducing the solids being transported downstream from Ribeirão Ferro-Carvão to the Paraopeba River and directs the sediment laden water to the Fluvial Water Treatment Plant (ETAF) reservoir, which is already in full operation.

Sheet pilings curtain will reduce tailings flow
